**Flood Control Project Maintenance  
Levee Inspections**

**Fall 2010 Levee Maintenance Deficiency Summary Report**

**Reclamation District No. 2031 Elliot**

**Levee Inspection Report By Mile - Fall 2010**

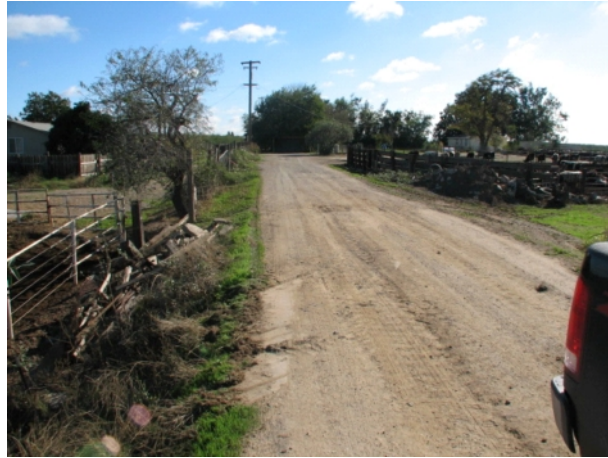
Levee Mile Report Line	1
Start Levee Mile	0.00
End Levee Mile	0.07
Location	Water Side
Category	Earthen Levee
Item	Encroachments

Fall 2009 photo looking upstream at beginning of unit 1. Water side to the left.

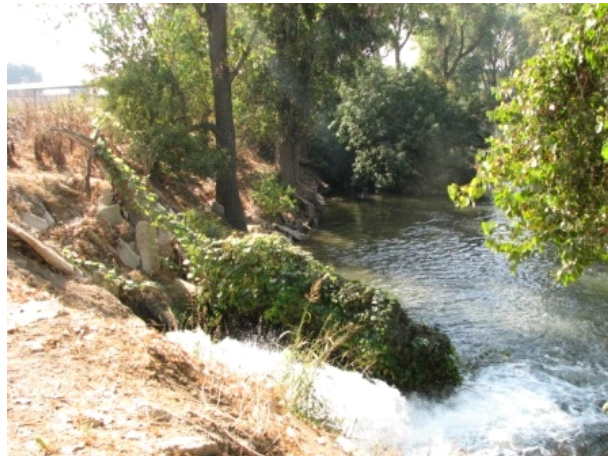
Levee Mile Report Line	5
Start Levee Mile	0.47
End Levee Mile	0.50
Location	Water Side
Category	Supplemental
Item	DWR Erosion Survey

5	0.47	0.50	Supplemental	DWR Erosion Survey	WS	M	Inspector Comments: 10/19/2010: No significant changes observed on site. Sloughing of the bank is occurring adjacent to an irrigation outlet structure. There is moderate to heavy vegetation along the bank that is well established. Broken chunks and slabs of concrete are used as rip rap and line the outside of the irrigation outlet structure. However, much of the rip rap along the slope is sloughing and could possibly lead to future slope instability. 08/05/2010: Recommended as a local maintenance issue, per CLRO. [2010 SiteID: RD2031U01RM0.48]	37.704740 ° -121.159140 °	37.704740 ° -121.159140 °	1 Y
6	0.52	0.52	Earthen Levee	Vegetation	WS	M	Remove the wild growth other than native grasses from the levee slopes.	37.704050 ° -121.159578 °	37.704050 ° -121.159578 °	2
7	0.55	0.65	Earthen Levee	Encroachments	LS	CO	Buildings Inspector Comments: Corrals and house on levee slope and crown.	37.703626 ° -121.159714 °	37.702648 ° -121.160700 °	969 Y

Looking downstream of the site. Note the irrigation outlet is operational.

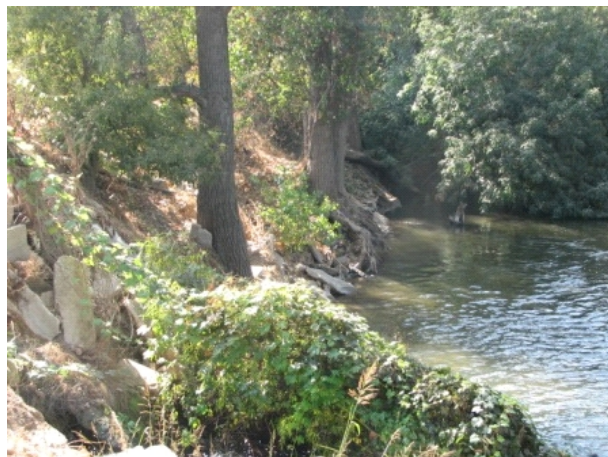
Levee Mile Report Line	5
Start Levee Mile	0.47
End Levee Mile	0.50
Location	Water Side
Category	Supplemental
Item	DWR Erosion Survey

Looking downstream of the site.

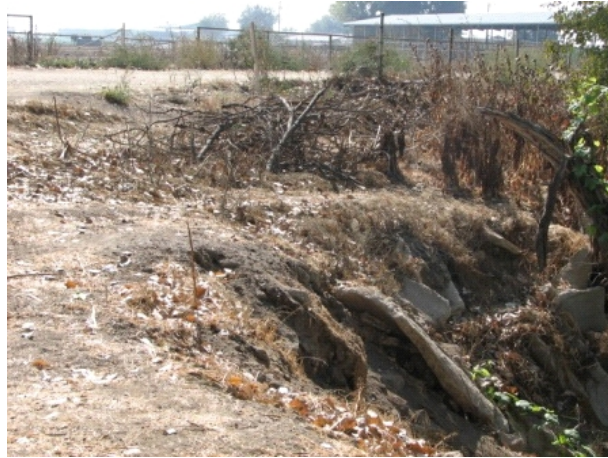
Levee Mile Report Line	5
Start Levee Mile	0.47
End Levee Mile	0.50
Location	Water Side
Category	Supplemental
Item	DWR Erosion Survey

View of the current condition of the levee slope just above the irrigation outlet.

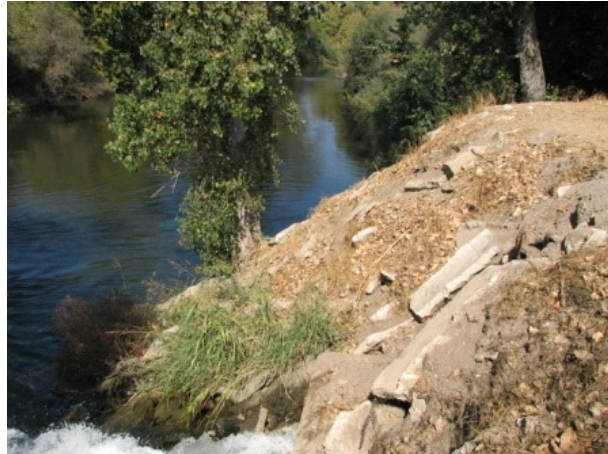
Levee Mile Report Line	5
Start Levee Mile	0.47
End Levee Mile	0.50
Location	Water Side
Category	Supplemental
Item	DWR Erosion Survey

Upstream view of the site.

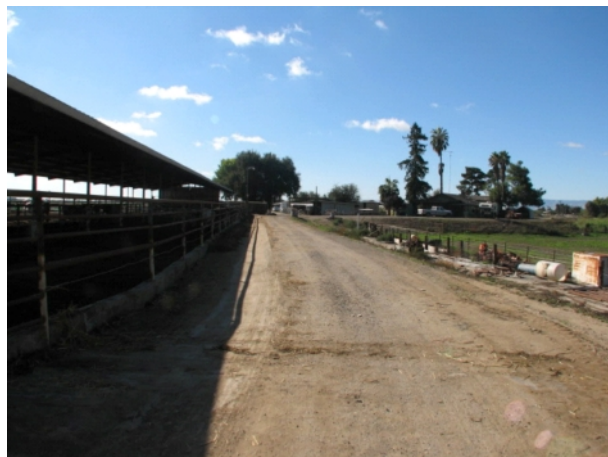
Levee Mile Report Line	7
Start Levee Mile	0.55
End Levee Mile	0.65
Location	Land Side
Category	Earthen Levee
Item	Encroachments

Fall 2009 photo of livestock pens and house on landside slope.

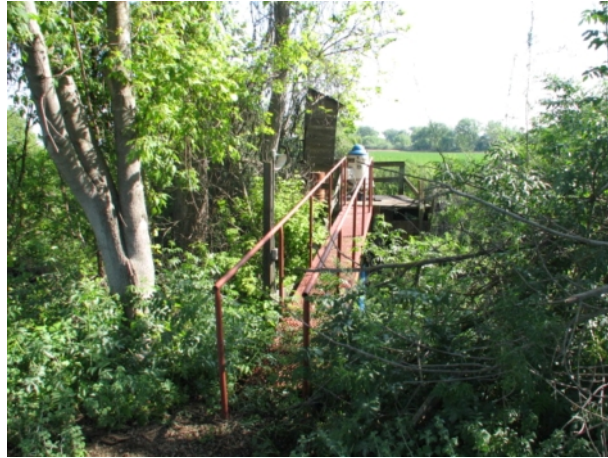
Levee Mile Report Line	17
Start Levee Mile	1.27
End Levee Mile	1.27
Location	Water Side
Category	Earthen Levee
Item	Encroachments

Irrigation intake pump and pipe.

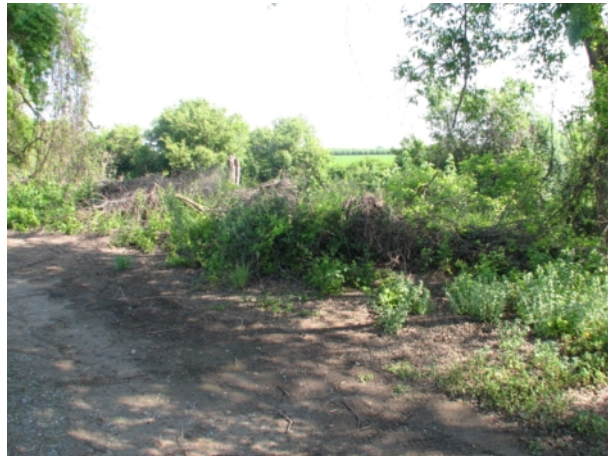
Levee Mile Report Line	18
Start Levee Mile	1.27
End Levee Mile	1.27
Location	Water Side
Category	Earthen Levee
Item	Vegetation

Vegetation on waterside slope and crown.

18	1.27	1.27	Earthen Levee	Vegetation	WS	M	Remove the wild growth other than native grasses from the levee slopes. Inspector Comments: Improvements made.	37.699534 ° -121.169922 °	37.699534 ° -121.169922 °	977 Y
19	1.54	1.55	Earthen Levee	Vegetation	WS	C	Remove the wild growth other than native grasses from the levee slopes. Inspector Comments: This vegetation is Hemlock rather than Elderberry.	37.699317 ° -121.173762 °	37.699242 ° -121.173880 °	8
20	1.64	1.64	Earthen Levee	Encroachments	LS	M	Tree or limb Inspector Comments: Almond tree on levee slope.	37.698308 ° -121.175206 °	37.698308 ° -121.175206 °	12
21	1.73	1.73	Earthen Levee	Encroachments	LS	M	Tree or limb	37.697619 ° -121.176694 °	37.697619 ° -121.176694 °	13
22	1.88	1.88	Interior Drainage & Piping Systems	Culverts: Inlets / Outlets	WS	A	Inspector Comments: Drainage culvert not in use.	37.695684 ° -121.177522 °	37.695684 ° -121.177522 °	14

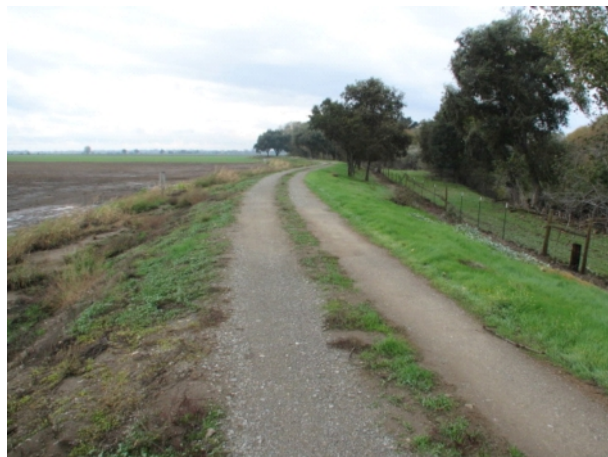
Levee Mile Report Line	25
Start Levee Mile	2.52
End Levee Mile	2.52
Location	Water Side
Category	Earthen Levee
Item	Vegetation

Acceptable vegetation maintenance on levee slopes.

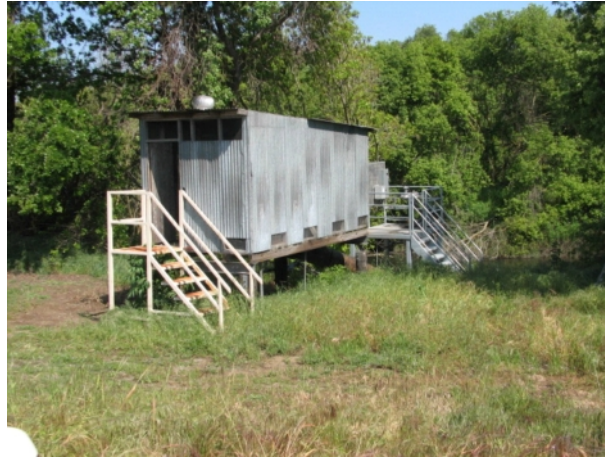
Levee Mile Report Line	32
Start Levee Mile	3.72
End Levee Mile	3.72
Location	Water Side
Category	Earthen Levee
Item	Encroachments

Irrigation intake on waterside berm.

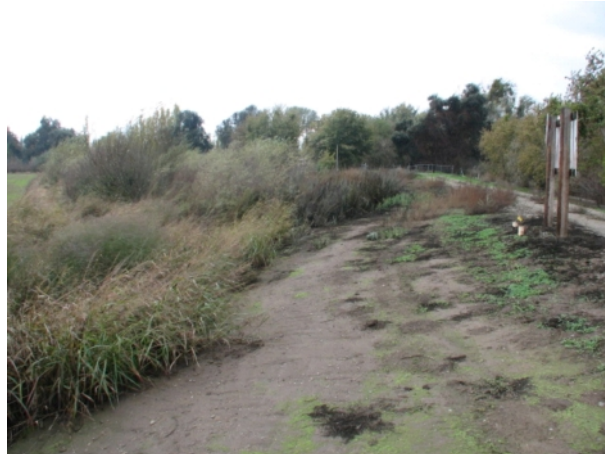
Levee Mile Report Line	36
Start Levee Mile	4.39
End Levee Mile	4.43
Location	Land Side
Category	Earthen Levee
Item	Vegetation

Obstructive vegetation on levee slope and within 10' of levee toe.

35	4.33	4.33	Earthen Levee	Animal Control	LS	C	No rodents visible, but rodent burrows visible; need to backfill and compact or grout borrows.	37.687362 ° -121.206151 °	37.687362 ° -121.206151 °	22
36	4.39	4.43	Earthen Levee	Vegetation	LS	M	Remove the wild growth other than native grasses from the levee slopes.	37.686971 ° -121.207385 °	37.686585 ° -121.207802 °	32 Y
37	4.45	4.45	Earthen Levee	Encroachments	WS	W	Pipe Inspector Comments: Two irrigation intakes	37.686376 ° -121.207935 °	37.686376 ° -121.207935 °	23
38	4.60	4.80	Earthen Levee	Encroachments	LS	PO	Landscaping Inspector Comments: Poplars and othe landscaping at levee toe.	37.684474 ° -121.208447 °	37.682167 ° -121.209098 °	982
39	5.35	5.35	Earthen Levee	Encroachments	WS	PO	Landscaping Inspector Comments: Wild rose	37.678363 ° -121.217375 °	37.678363 ° -121.217375 °	25
40	5.41	5.41	Earthen Levee	Encroachments	LS	CO	Landscaping Inspector Comments: Wild Rose Bushes	37.677641 ° -121.217499 °	37.677641 ° -121.217499 °	983

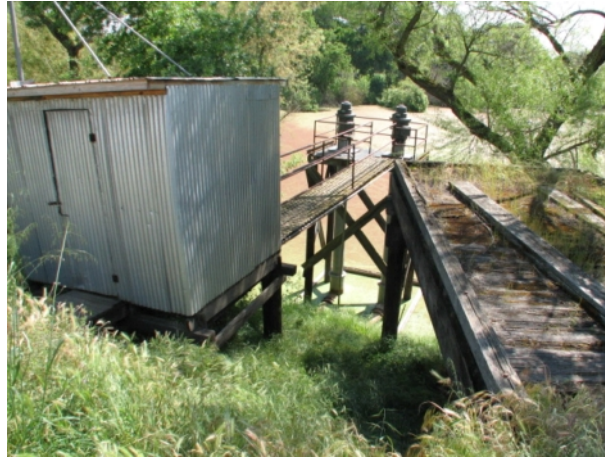
Levee Mile Report Line	1
Start Levee Mile	0.22
End Levee Mile	0.22
Location	Land Side
Category	Earthen Levee
Item	Encroachments

Drainage discharge pumps and housing on steep waterside slope.

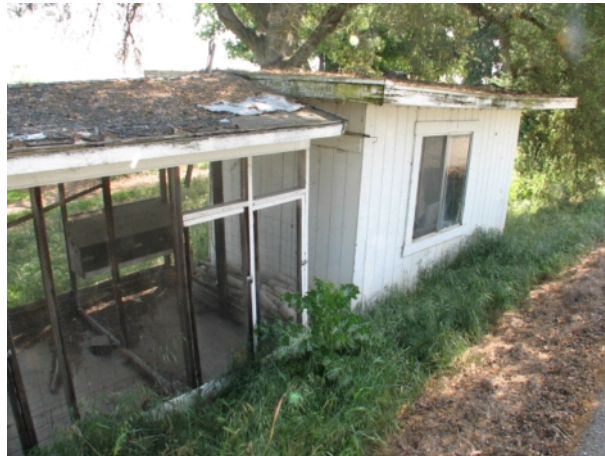
Levee Mile Report Line	2
Start Levee Mile	1.36
End Levee Mile	1.36
Location	Land Side
Category	Earthen Levee
Item	Encroachments

Small structure on levee slope.

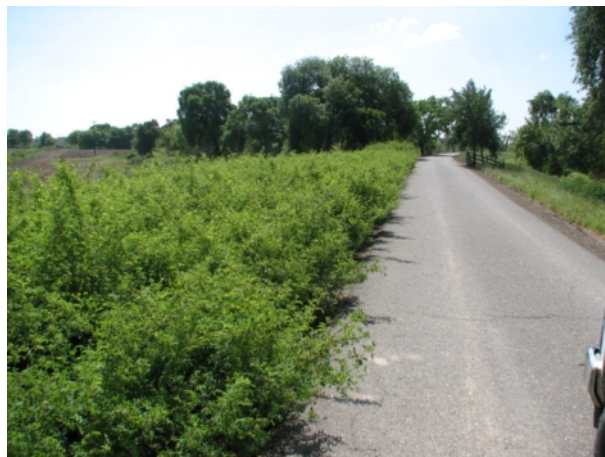
Levee Mile Report Line	3
Start Levee Mile	1.45
End Levee Mile	1.45
Location	Land Side
Category	Earthen Levee
Item	Encroachments

Wild rose on levee slope.

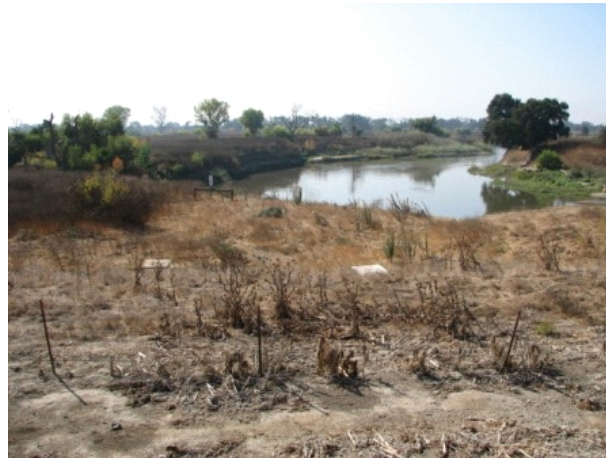
Levee Mile Report Line	7
Start Levee Mile	4.33
End Levee Mile	4.37
Location	Water Side
Category	Supplemental
Item	DWR Erosion Survey

6	3.97	3.97	Earthen Levee	Encroachments	WS	C	Landscaping Inspector Comments: Pepper trees are on the waterside slope. Trimmed for visibility.	37.636629 ° -121.191150 °	37.636629 ° -121.191150 °	968
7	4.33	4.37	Supplemental	DWR Erosion Survey	WS	W	Inspector Comments: 10/19/2010: There is active scouring occurring on the bank due to the nature of the flow and the lack of armor protection. There is also a fallen log immediately downstream of where the erosion has occurred and is protruding outward, possibly creating an eddy and scouring the bank. With the remaining 100-foot wide berm, the levee prism is not yet affected. However, the bank will continue to degrade, and eventually intrude into the levee prism if no protection is put in place. Erosion site is recommended for annual assessment and monitoring during flood events.[2010 SiteID: RD2031U02RM78.7]	37.631716 ° -121.189370 °	37.631716 ° -121.189370 °	1 Y

From the berm looking upstream. Note the perpendicular approach of incoming flow onto the bank.

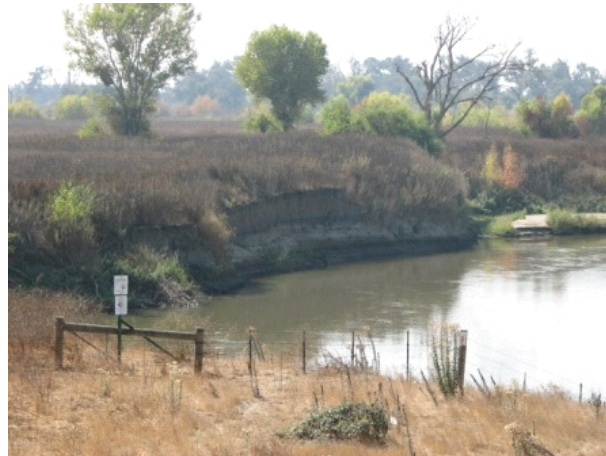
Levee Mile Report Line	7
Start Levee Mile	4.33
End Levee Mile	4.37
Location	Water Side
Category	Supplemental
Item	DWR Erosion Survey

Upstream view of adjacent bank affected by erosion.

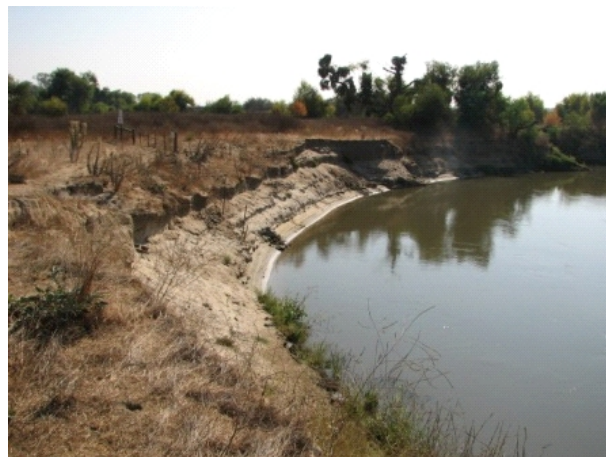
Levee Mile Report Line	7
Start Levee Mile	4.33
End Levee Mile	4.37
Location	Water Side
Category	Supplemental
Item	DWR Erosion Survey

Upstream view of scouring.
